**PEQUONNOCK RIVER BASIN
BRIDGEPORT, CONNECTICUT**

**BUNNELLS POND DAM
CT 00076**

**PHASE I INSPECTION REPORT
NATIONAL DAM INSPECTION PROGRAM**

AUGUST 1978

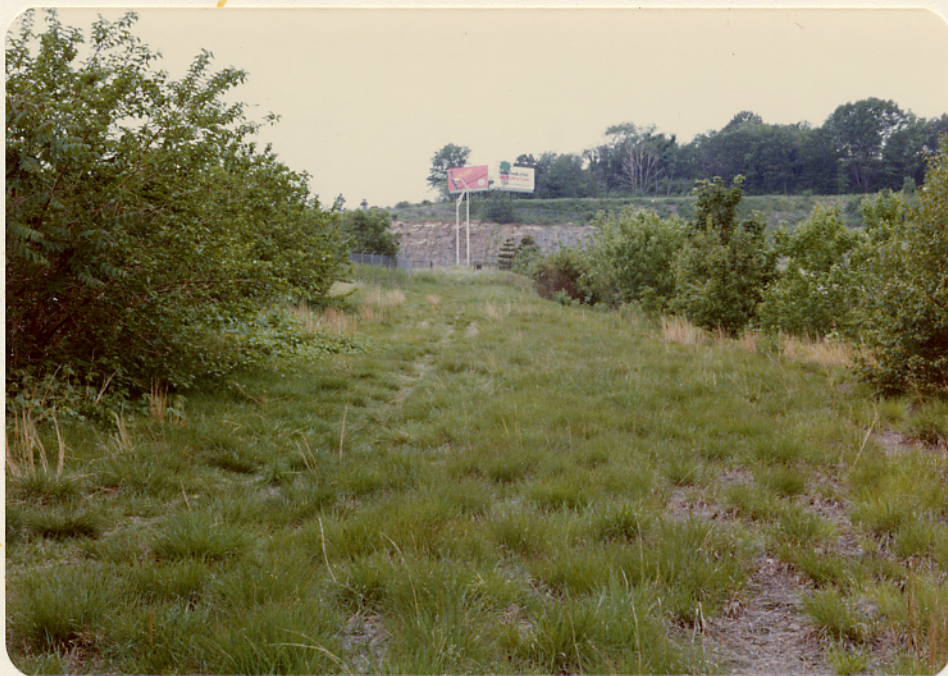
Crest - The crest of the dam is in good condition with no evidence of cracks or erosion. It appears, however, that the elevation of the crest is about one foot below the top of the spillway abutment near the right abutment and at the right end of the dam.

PHOTO NO.1 - General view of crest of dam to right of spillway

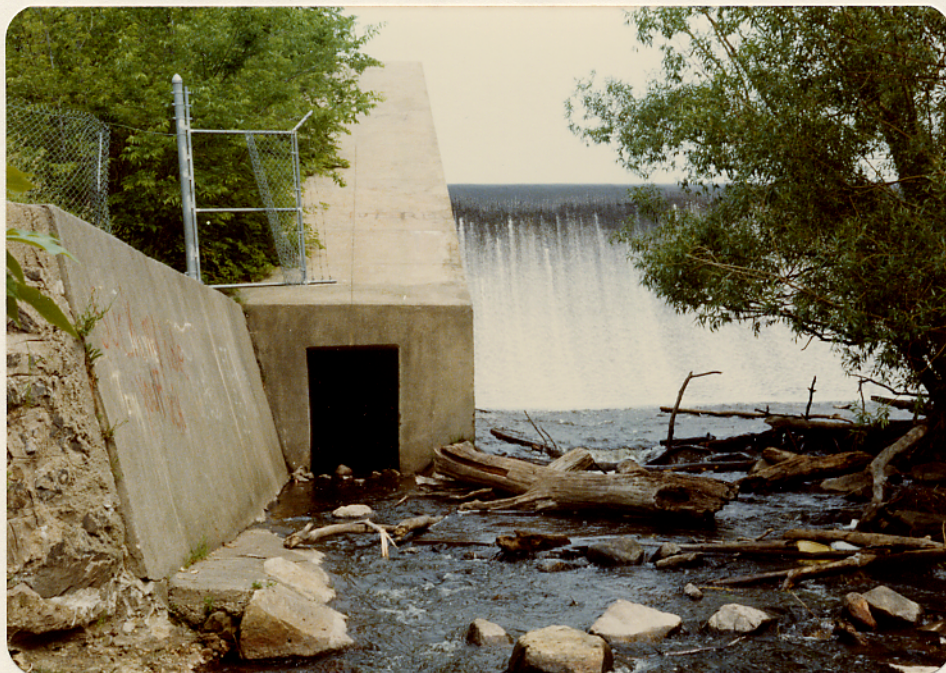
PHOTO NO.2 - Right abutment and low level outlet, and spillway.

1. Repair and reactivate the low level intake to allow the reservoir water level to be lowered in cases of emergency or for maintenance.
2. Based upon the rough computation in Appendix D, the dam spillway capacity will be exceeded by the Test Flood. More sophisticated flood routing should be undertaken by hydrologist/hydraulics engineers to

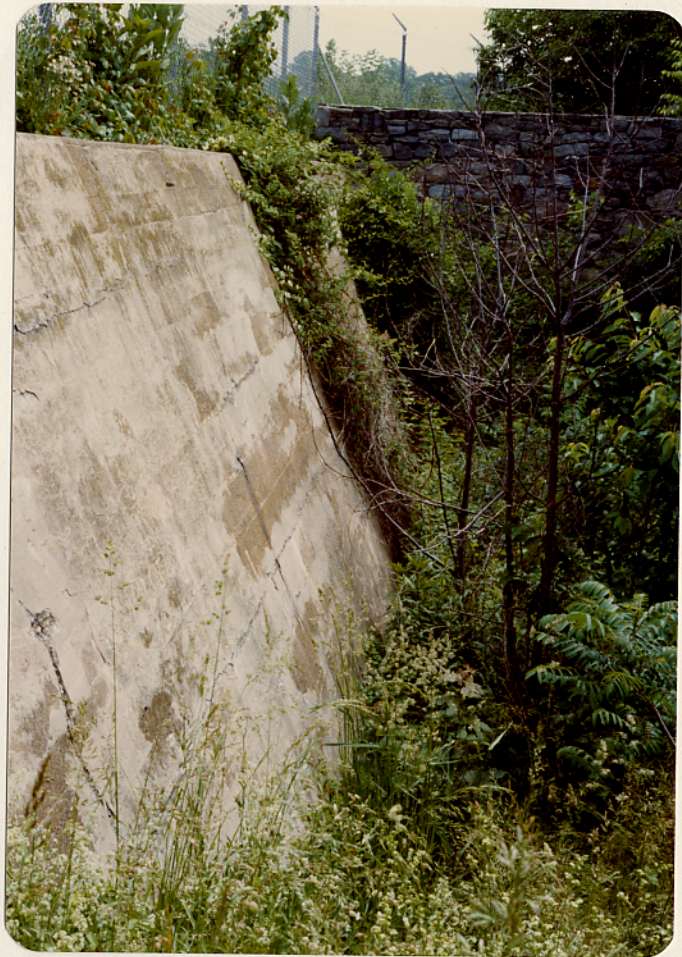
At the right end of the dam, there are two retaining walls in good condition, one consisting of stone and concrete sections, and the other a concrete section.

PHOTO NO.3 - Retaining wall downstream to right end of dam.

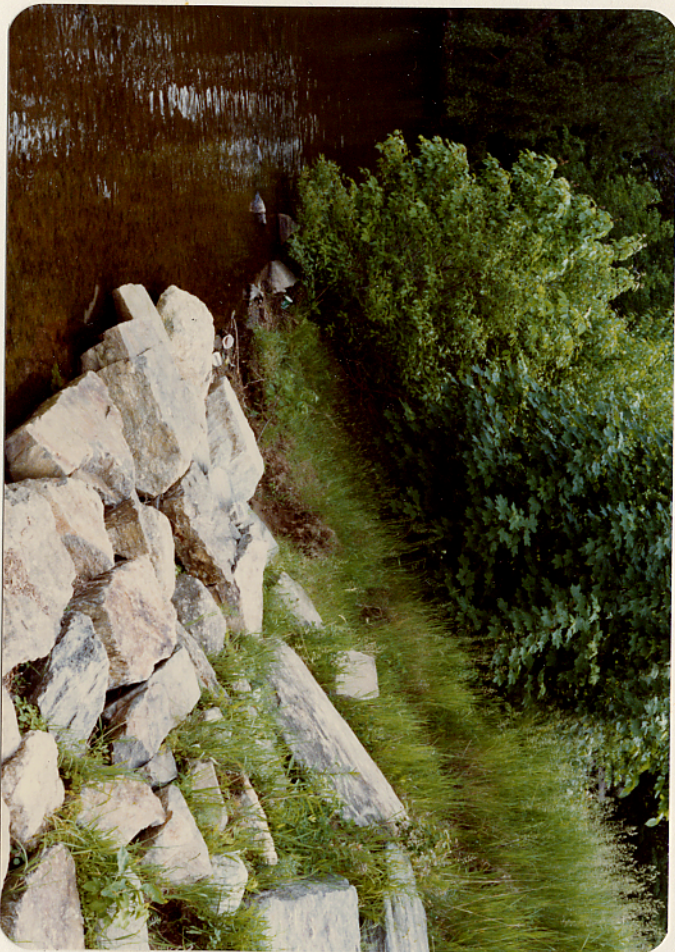
PHOTO NO.4 - Riprap and unprotected reservoir embankment to left of spillway.
